Damage Analysis of Centrifugal Exhaust Fan in Air Arrangement in Room Painting

Ahmad Hipni¹, Jimmy Sabar HP Sitanggang², Humiras Hardi Purba³ ^{1,2,3}Master of Industrial Engineering, Mercu Buana University, Jakarta, Indonesia

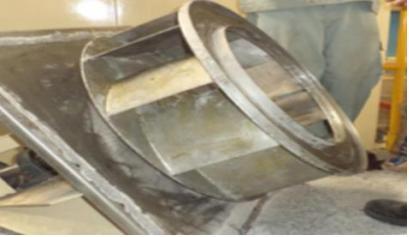
Fig. 5. Centrifugal impeller

• Impeller damage is usually caused by friction with housing fans and impeller corrosion due to air containing chemicals. This is the flow of noise and vibration on the exhaust fan becomes larger. As can be seen in Fig. 5.

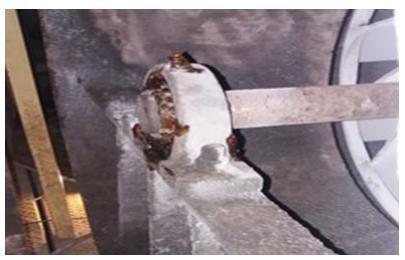
Fig. 6. Fillow block bearing

• Damage to the bearing in the form of lubrication in the interior, damage in the form of longitudinal cracks towards the center of the outer bearing, scratches and deformation on the surface due to friction and effect can be seen in Fig. 6.

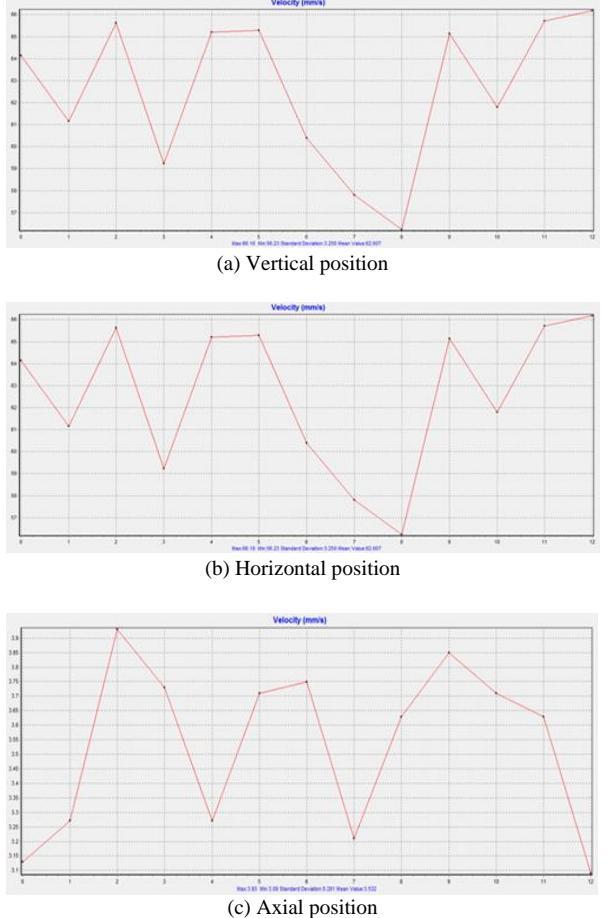
Fig. 7. Vibration chart measurement results

The vibration spectrum graphs on the bearings and motors as shown in Fig. 6 show that the position of the vertical velocity vibration is still in the red column with a value of 55.395 mm / s. While in horizontal position also exceeded the permissible safe limit or red column based on ISO 2371 with value 62.607 mm / s. Although the axial velocity vibration position is still in a safe limit with a value of 3,532 mm/s. From the trend chart shows the breakdown of the bearing on the bearings where the large amplitude appears in the vertical position then increases the horizontal position and decreases in the axis. This indicates that there is damage to the bearing and impeller disconscience. Spectrum analysis of vibrations is performed on all parts of the centrifugal exhaust fan, obtaining the symptoms of damage obtained. And can be seen in Table 1 as follows,

From the above table it can be seen that the exhaust fan has some indication of damage, but the most dominant damage symptom is the bearing that causes vibration and unbalance, where the damage symptoms are seen in the horizontal and vertical position of the bearing exhaust fan that has the highest vibration value compared to axial position, which is 62.607 mm/s. In addition, the signs of damage are damage to the rusty impeller.

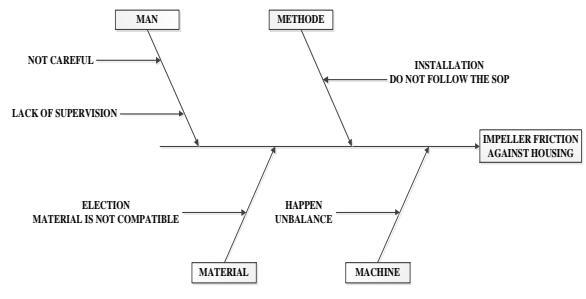
Fig. 8. Ishikawa Diagram Impeller with Housing

Analysis of the root causes of friction between impellers and housing using the Ishikawa diagram as shown in Figure 8, where friction can occur due to several things such as errors in installation, failure of the shaft, failure of the bearing, and

unbalance. From the checks that have been done, it is known that friction between impellers and casings is caused by failure of the bearing. This can be seen when the disassembly of the exhaust fan turns out that the bearing is damaged and corroded due to lack of lubrication in the bearing .. Damage to this bearing causes the shaft to move forward at high speed and results in rotation of the impeller on the housing. Damage analysis is carried out continuously on each type of damage that appears until the root is obtained from the damage that occurs on the last ishikawa diagram as seen in Fig. 9.

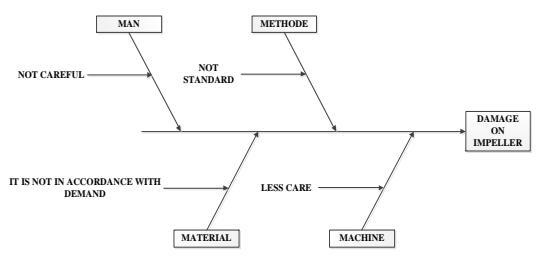
Fig. 10. Ishikawa Damage diagram on the impeller

From the inspection, it is known that impeller damage is caused by imbalance, this can be seen in the result of vibration checks where there is an indication of imbalance in the centrifugal exhaust fan that has the highest vibration value compared to other damage symptoms which causes the most dominant damage effect. An imbalance causes vibration and causes relaxation at the base, so that the bolt bolt is damaged and released.

Based on the type of damage that occurs and the source analysis of the damage, appropriate improvement strategies can be formulated using FMEA to prevent further damage. Preparation of FMEA is focused on faulty components, bearings and propellers. For unbalanced problems, it can be done after changing the bearings while damage to the impeller can still be fixed if the damage is not too severe. To determine the type of imbalance, you can check the value of the vibration when the motor is loaded. The vibration value is taken and recorded when the motor is controlled so that the motor load is stopped. If the vibration value decreases slowly then this indicates that the imbalance is mechanical imbalance, while electrical imbalances occur if the motor vibration value decreases dramatically as the load is stopped. From an unbalanced problem, the most important step to overcome this problem is to offset the rotor with mass repayment mass or reduce the rotor mass (drilling). If the problem is an electric unbalance due to the motor stator coil, the rewind is done. If the imbalance problem is solved, the next step is to repair the base, and tie the bolt. This is important because these components also work to make the rigid motors also function as vibration dampers.
