Effect of Quality Control Circle Application to the Employee Work Productivity of PT Z

Abstract: The Quality Control Circle (QCC) was first introduced by a quality control expert namely Prof. Kaoru Ishikawa in 1962 with the Japanese Union of Scientists and Engineers (JUSE). The first company to implement the concept of QCC was Nippon Wireless and Telegraph Company in 1962. This research was conducted at PT Z Company which had implemented the QCC, aiming to analyze the role of QCC on employee work productivity. Samples were taken in the Trimming cluster with nine respondents. The method used in this research is applying eight steps seven tools, solving problems following the 8 steps step and using 7 statistical tools. The results of research at PT Z found that the biggest defect is a scratch cross shaft with a total damage of 12 units/month. The dominant cause of damage is that there are no special tools for installation (the correlation factor is 0.919) and the installation process on the floor (the correlation factor is -0.832). Furthermore, after repairing it by creating special tools for cross shaft installation, which is placed on the table so that the installation is no longe

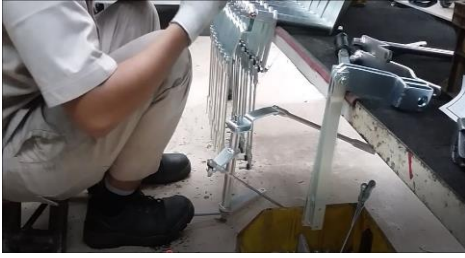
Fig. 4. Fuso scratch shaft underneath

From the depicted picture, the problem then is found, the point is how to reduce the scratch cross shaft defects, and the dominant damage can be seen as in Figure 4 below.

The picture above explaining the process of cross shafts installation on the floor that cause scratches on the bottom.

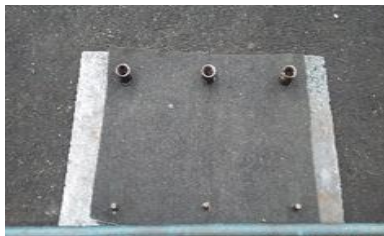
Figure 6. Special tools

So then it is decided to make a special tools that was coated with a protector which is used to install the cross shaft so that no scratch at the bottom occurred again, and the installation process was carried out on the table so that the installation no longer done while bending.

In accordance with the working plan that is prepared in step 4, the special tools are made for the installation of cross shafts that are placed on the table, as shown in Figure 6 and Figure 7 below.

No.	Dominant causes	why	what	where	when	who	how
1	there are no special tools	so the defect in the production process is reduced	made special tools	at workshop PT Z	Oct-17	Wenda Susanto	Figure 6. special tools
2	the assy process is difficult	so that is the assy process is easy	made special tools	Sub Assy	Oct-17	Wenda Susanto	Figure 7. The installation process is not done on the floor

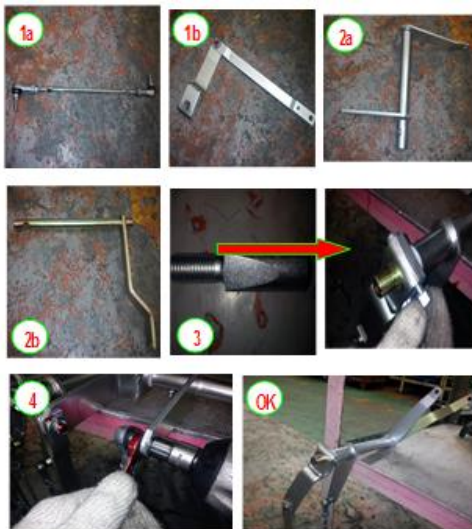
Fig. 8. SOP (Standard Operation Procedure) before improvement

Standard operation procedure before improvement is as shown in Figure 8 below.

1. Attach the rod select (MC 411872) to the lever select (MC411372),
2. Attach the bushing (MC401563) and housing assy (MC411887X) to the cross shaft (MC418438).
3. Attach pin lock
4. Attach the rod select (MC411872)
5. Recheck again

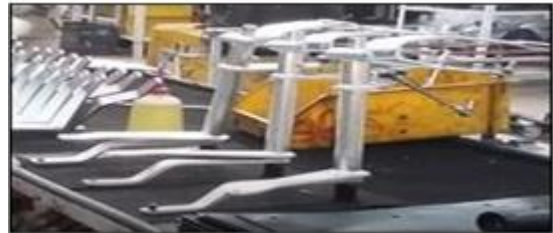
Fig. 9. SOP (Standard Operation Procedure) after improvement

As for, the SOP (Standard Operation Procedure) after the improvement is presented in Figure 9 below.

1. Attach the cross shaft to special tools
2. Attach the rod select (MC411872) to Lever select (MC411372)
3. Attach the bushing (MC401563) and housing assy (MC411887X) to the cross shaft (MC418438)
4. Attach pin lock
5. Attach the rod select (MC411872)
6. Moment nut tightened
7. Read mark
8. Recheck again
