A Study on Indian Railways Initiates “Project Utkrisht (उत्कृष्ट)” Regarding Safety Concern

Abstract: This work aims to identify the Root cause of failures and to prevent the occurrence of same in future we can use CBC instead of screw coupling in Utkrisht type of coach. To this end following research work is also carried out with the proposed safe model of implementation and improvement of train number 12311/12312 Howrah-Kalka Mail of Eastern Railway and also for the other existing trains which are decided to upgrade under this scheme.

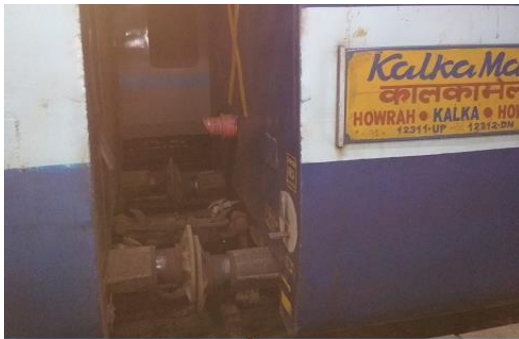
Screw coupling: Screw coupling and the side buffers serve the aforesaid purpose in case of the draw and buffing gears respectively in case of ICF coaches. Screw coupling not only gives the boost but also let two coaches connect in the formation of a continuous rake. The two jaws of the screw on both sides are guarded with spring and rubber to minimize the vibration the hauling force produces. They are called the Draft Gears. (Figure 1).

Fig. 1. Illustration of Screw coupling of ICF Coaches

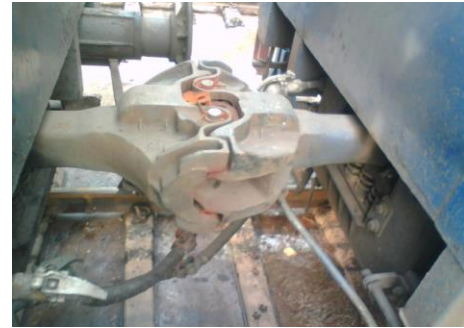
Center buffer coupling: Due to certain limitations of the age-old screw coupling system, CBC becomes the most useful & viable choice. There are certain features of CBC which makes it a unanimous choice & extensively used in most of the freight cars, & all of the LHB coaches of Indian Railways. The centre buffer couplers used on LHB coaches are tight lock centre buffer couplers of AAR type H. The centre buffer coupler combines the draw and buffering gear in one. It is able to transmit both the tensile and the compressive forces, further the tight lock coupler by its special design hinders the climbing of the vehicles in case of an accident. [4], [5]. There are certain features of CBC which makes it a unanimous choice & extensively used in most of the freight cars, EMU coaches & all of the LHB coaches of Indian Railways. (Figure 2).

Fig. 2. Illustration of AAR (H) type Tight Lock Center Buffer Coupling of ICF Coaches

Salient features of CBC: It transmits both draft & buffing load between vehicles and to/ from under-frame. It absorbs high-frequency forces during impact & dissipates low-frequency forces to protect the vehicle from damage. It has got multifunctional units like Draft + Buffing & Automatic FP + BP (Pressure Gauge) connections.

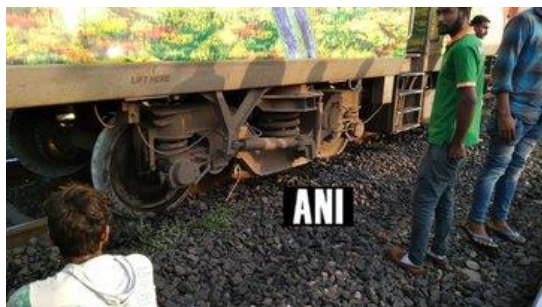
Fig. 3. Illustration of Thiruvananthapuram Rajdhani (Train No.12431, Thiruvananthapuram to Hazrat Nizamuddin) derailed on 18th/Oct /2018 [6]

Date of Accident	Accident Details
18/ Oct /2018	Two coaches of Thiruvananthapuram Rajdhani (TVC-Thiruvananthapuram Central to NZM-Hazrat Nizamuddin) (Train no.12431) derailed on the morning when it was hit by a truck at the level crossing between Meghnagar and thandla rail section of Ratlam division. A total of 48 passengers were sitting in these two coaches. However, none of them is injured.
Observation of 18/Oct/2018	It is observed that Rajdhani train running at speed more than 100 km/hr and Collision with a truck trying to cross train track and Due to this Train derailment happened of two AC coaches in which total of 48 passengers was sitting in AC Compartment and all life is saved. Because of one of the reasons for life-saving of 48 passengers was CBC. This is one of the best example of CBC that it prevented huge damage of coaches even after collision & the coupling was also not broken (due to Jerk) which also leads to the survival of life of 48 Individuals passenger travelling on 18/Oct/2018.

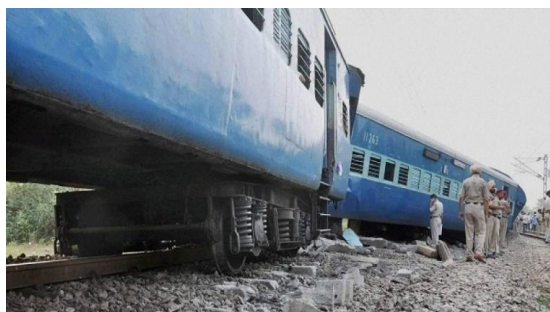
Fig. 4. Illustration of New Farakka Express (New Delhi to Malda Town) (Train No. 14003), derailed on 10th/Oct/2018 [6]

10/ Oct /2018	New Farakka Express (MLDT-Malda Town to NDLS-New Delhi) (Train no.14003) accident: 7 were killed &, 9 Coaches Derailed near Raebareli, Uttar Pradesh.
Observation of 10/Oct/2018	It is observed that New Farakka express train running an accident happened may be due to Improper maintenance of the train tracks or lack of signal communication by controller due to this reason derailment in 5 coaches happened Because of the breakdown of coupler after that the coach was lying out of the track and collision among the coaches happened. In this accident total, 7 people were killed and 40 passengers were injured. If the train would have CBC coupling then there wouldn't be many casualties in terms of loss of life and damage of coaches.

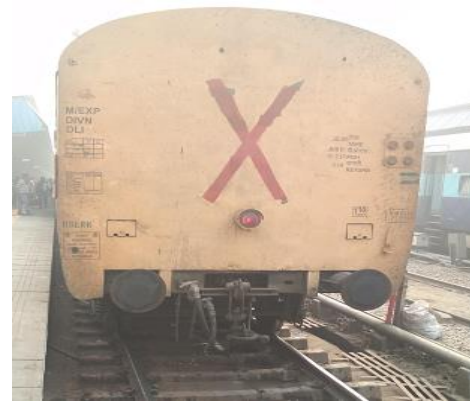
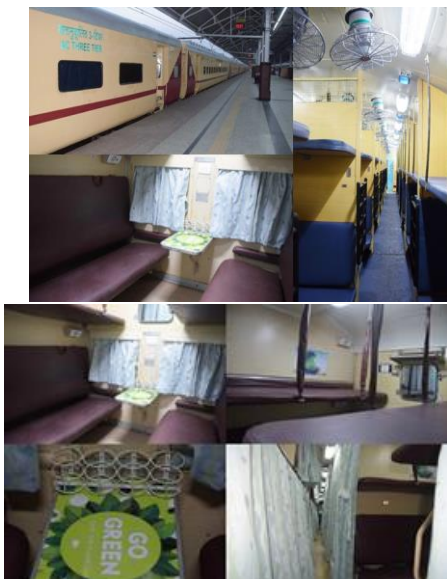
Fig. 5. Kalka Mail (Train Number: 12311 /12312) Upgraded ICF Coaches under Utkrisht Project with Interior, Washroom, Color Modification [8]
